# Ville Platte, City of

## **LDHH-DWRLF Water /Energy Efficiency Case for ARRA Green Project Reserve Drinking Water Line Replacement Project**

### **LRWA Leak Survey performed on the City of Ville Platte**

## Emergency Leak Survey

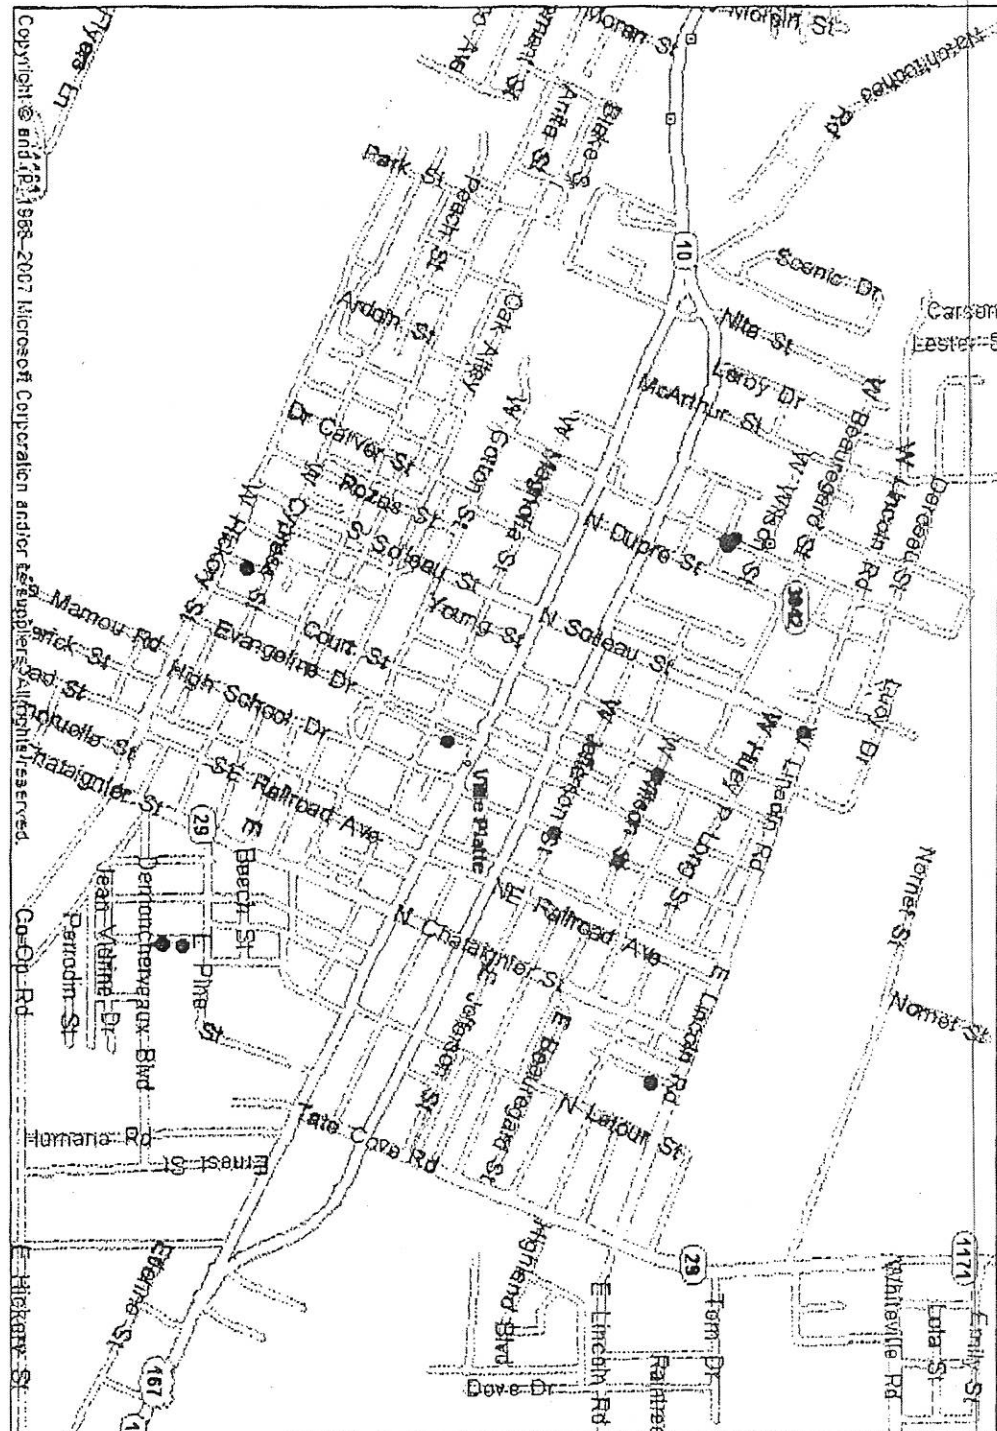
Leak Survey – June 2008

- Leaks needing immediate attention
