# Health Consultation

HURRICANE RESPONSE SAMPLING ASSESSMENT FOR  
DELATTE METALS

PONCHATOULA, TANGIPAHOA PARISH, LOUISIANA

SEPTEMBER 26, 2006

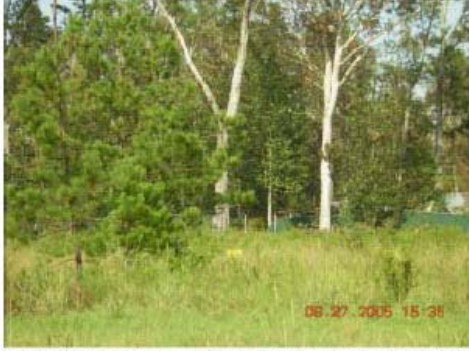
The August 29, 2005 landfall of Hurricane Katrina and the September 24, 2005 landfall of Hurricane Rita resulted in extensive flooding throughout southern Louisiana. On September 27, 2005, the CH2MHILL environmental consulting company conducted a site inspection of the Delatte Metals NPL site at EPA's request. The site visit was performed to determine whether the remedial actions in place at the site had been compromised by Hurricane Katrina. Appendix A includes photographs taken during the site visit. The site inspection team noted that in two places, trees had fallen on the perimeter fence, damaging the fence and mesh view barrier. The view barrier had fallen down in several places. A tree had also fallen near a monitoring well, but no damage to the well was observed [2]. None of the observed structural damages affect the remedy in place at the site. The property owner has the responsibility to repair these damages (personal communication, Katrina Higgins-Coltrain, EPA Site Contact).

DSCN1246-DM\_tree down across fence.JPG 2005/09/27 15:35:40

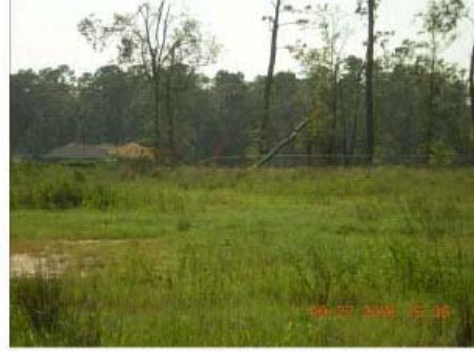
DSCN1247-DM\_tree down across fence.JPG 2005/09/27 15:36:26

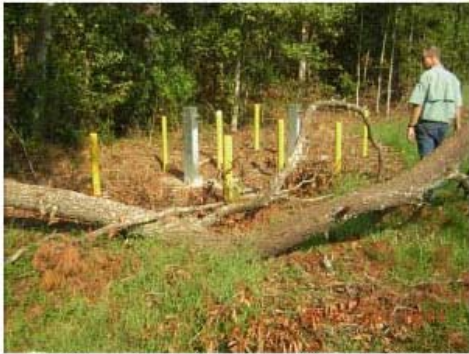
DSCN1250-DM\_tree down adj to well outside fence.JPG 2005/09/27 15:46:15

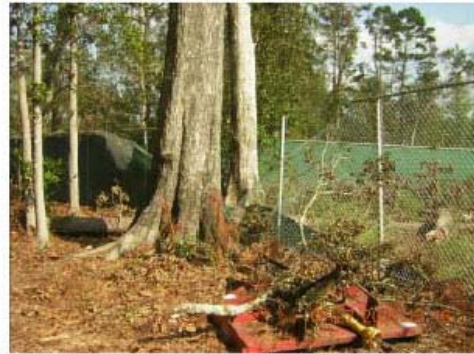
DSCN1251-DM\_tree down on fence.JPG 2005/09/27 15:46:15

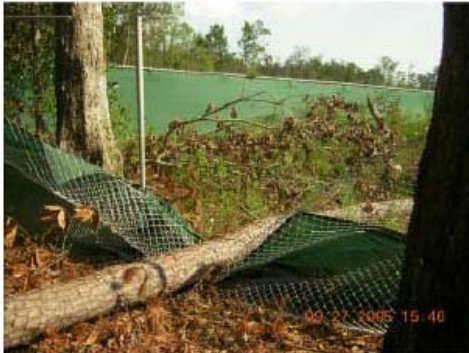
DSCN1252-DM\_tree down on fence.JPG 2005/09/27 15:46:37

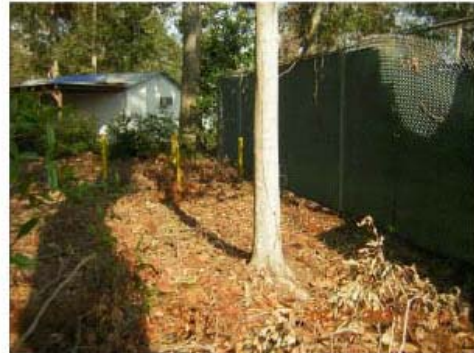
DSCN1253-DM\_tree down on fence.JPG 2005/09/27 15:46:50

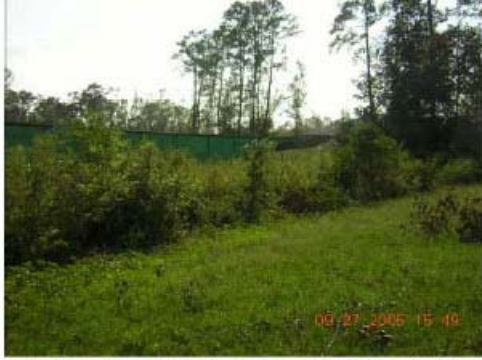
DSCN1254-DM\_Perimeter fence\_some view barrier damage.JPG 2005/09/27 15:49:46

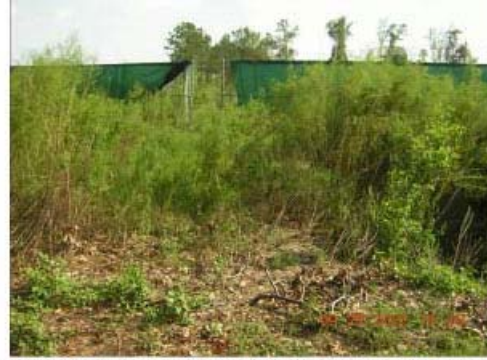
DSCN1255-DM\_Perimeter fence\_some view barrier damage.JPG 2005/09/27 15:50:00
