# Ville Platte, City of

## **LDHH-DWRLF Water /Energy Efficiency Case for ARRA Green Project Reserve Drinking Water Line Replacement Project**

### **LRWA Leak Survey performed on the City of Ville Platte**

## Emergency Leak Survey

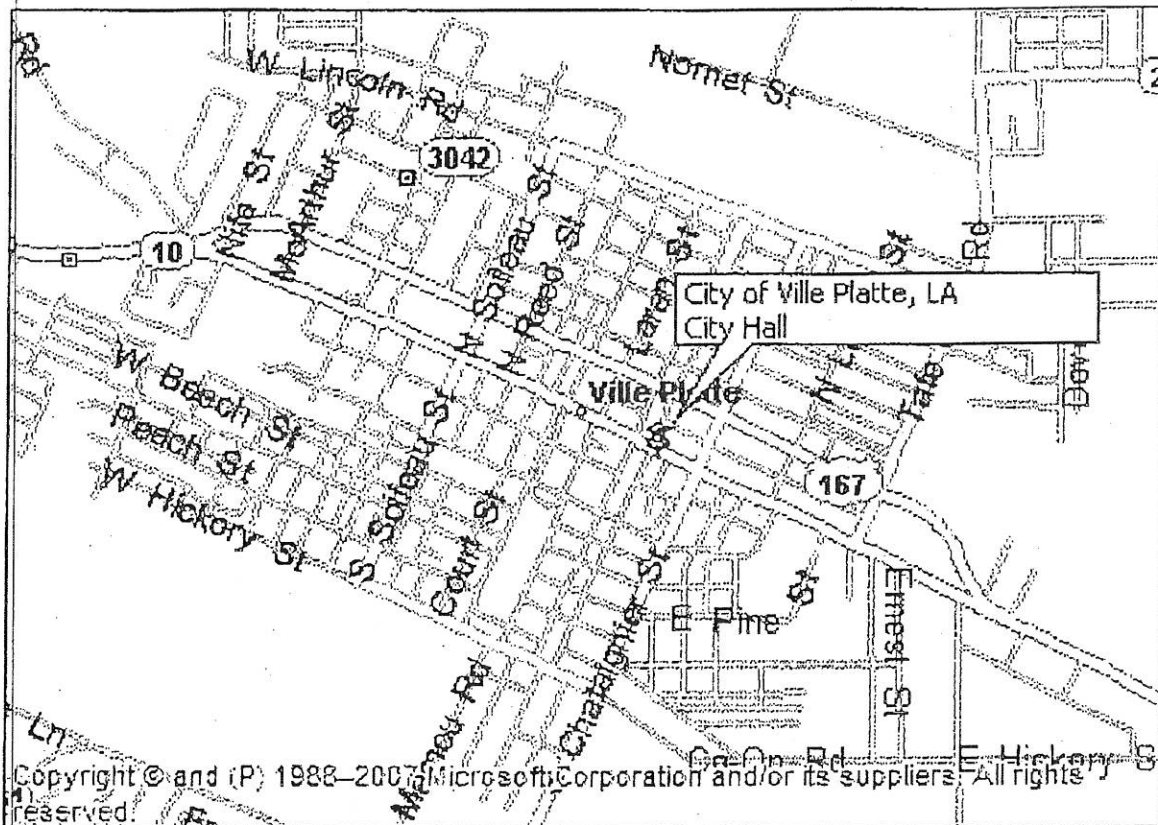
During a three (3) day period, LRWA personnel concentrated on the older parts of the water distribution system and located/detected 90 leaks in 81 locations. It is estimated that the leaks ranged in degree from 2 gpm to 60 gpm. Most of the large leaks are sub-surface leaks that are flowing directly into the storm sewers. **This system has one of the worse water losses in the state.**

LRWA found the Ville Platte water distribution system in dire need of repairs and replacement. In the Ville Platte Water System most of the piping is either cast iron or galvanized pipe. The galvanized pipe was installed in the 1940's – 1950's, some even earlier. The life expectancy of galvanized pipe is only 40-45 years. City repair crews are getting further behind on repairs because of the frequency of leaks, with some leaks being only feet apart and under concrete or asphalt roadways.

- ♦ That wells #6 and #8 be repaired sampled and placed in service.
- ♦ That immediate steps be taken to secure funding to replace all galvanized piping, including budgetary funding for some in-house replacement and equipment.
- ♦ That a preventive maintenance program be established and put in place.
- ♦ That meters be installed on wastewater treatment plant, to accurately monitor flows to the facility.
