Health Consultation

HURRICANE RESPONSE SAMPLING ASSESSMENT FOR GULF COAST VACUUM SERVICES

ABBEVILLE, VERMILION PARISH, LOUISIANA

SEPTEMBER 26, 2006

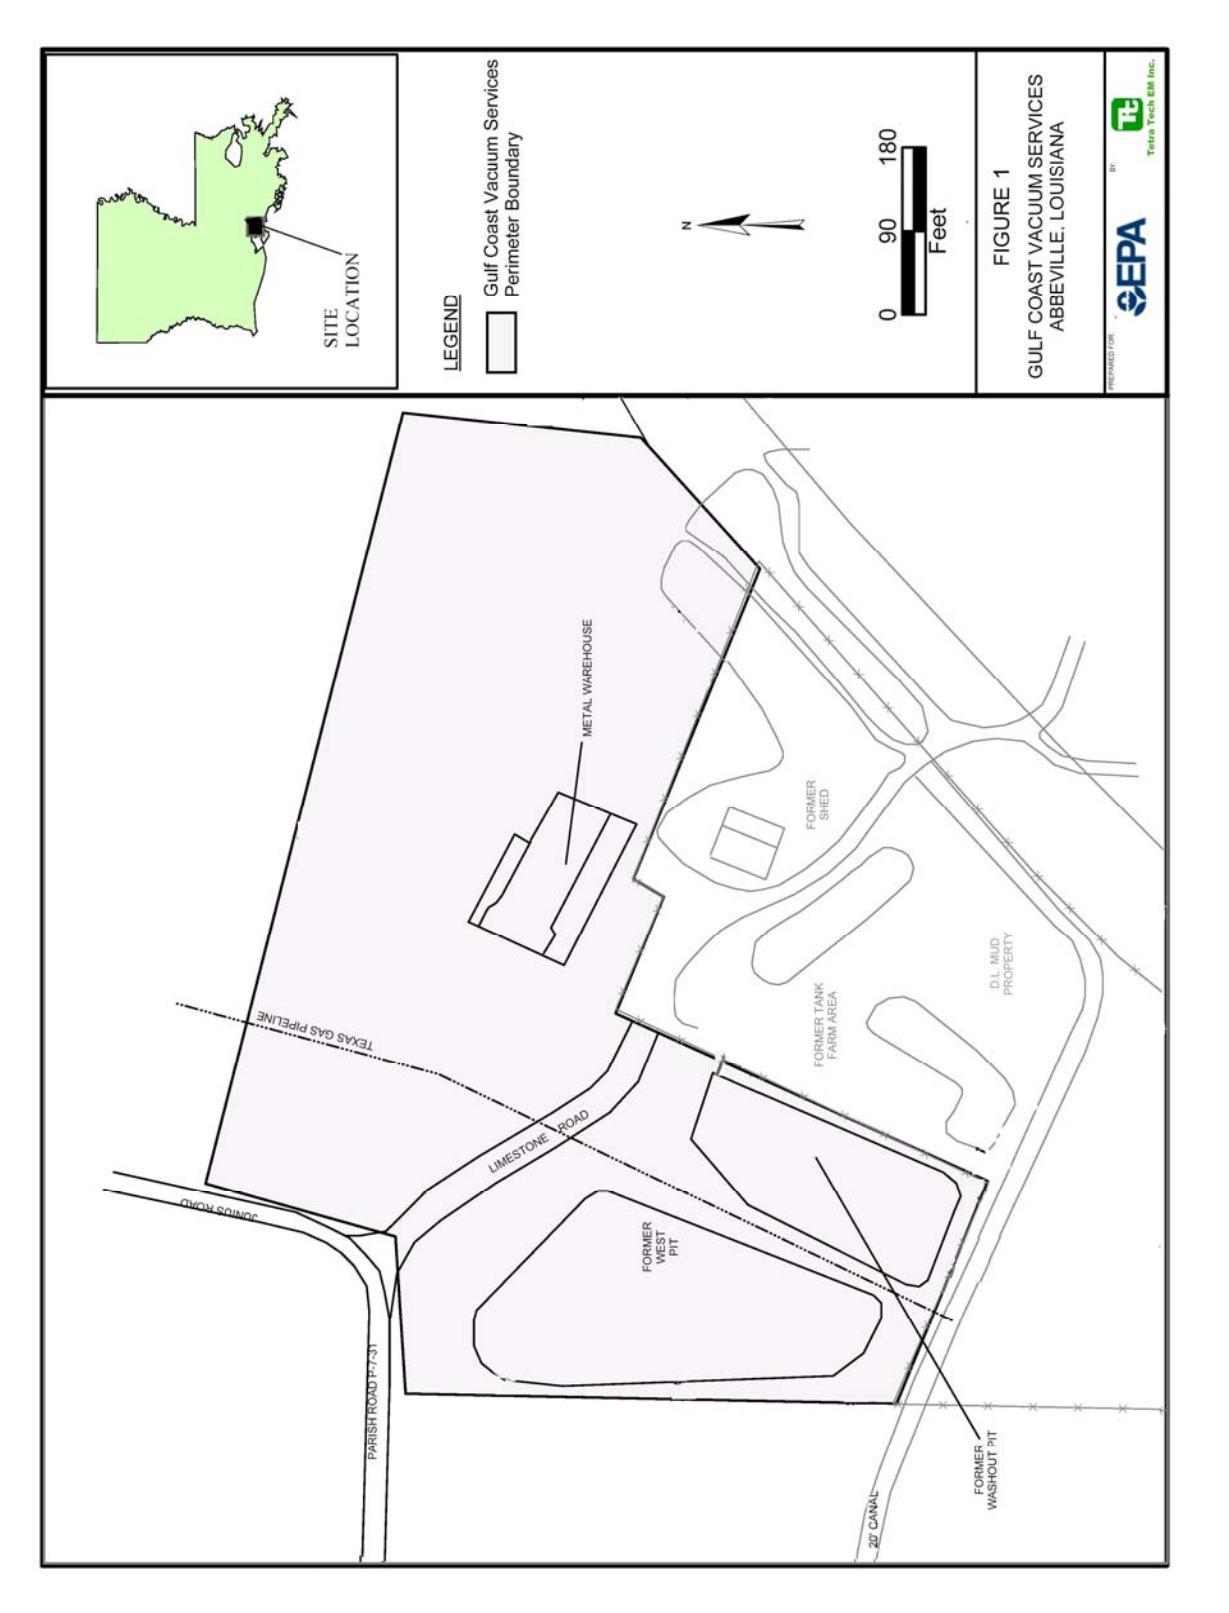
The GCVS site is located on Parish Road P-7-31, approximately 2.5 miles southwest of Abbeville, Louisiana and 1.5 miles west of the Vermilion River. Figure 1 shows the location and perimeter of the site. The site, which lies adjacent to another NPL site (D.L. Mud, Inc.), was once part of 25.56-acres of land known as the Galveston Houston Yard or the LeBoeuf Yard. The property was used for the storage and formulation of mud for barium sulfate-based oil field drilling. Waste oils and diesel fuel reportedly spilled onto the surface soils at the site, and illegal dumping of other wastes was also reported to have taken place during this time period [1,2].

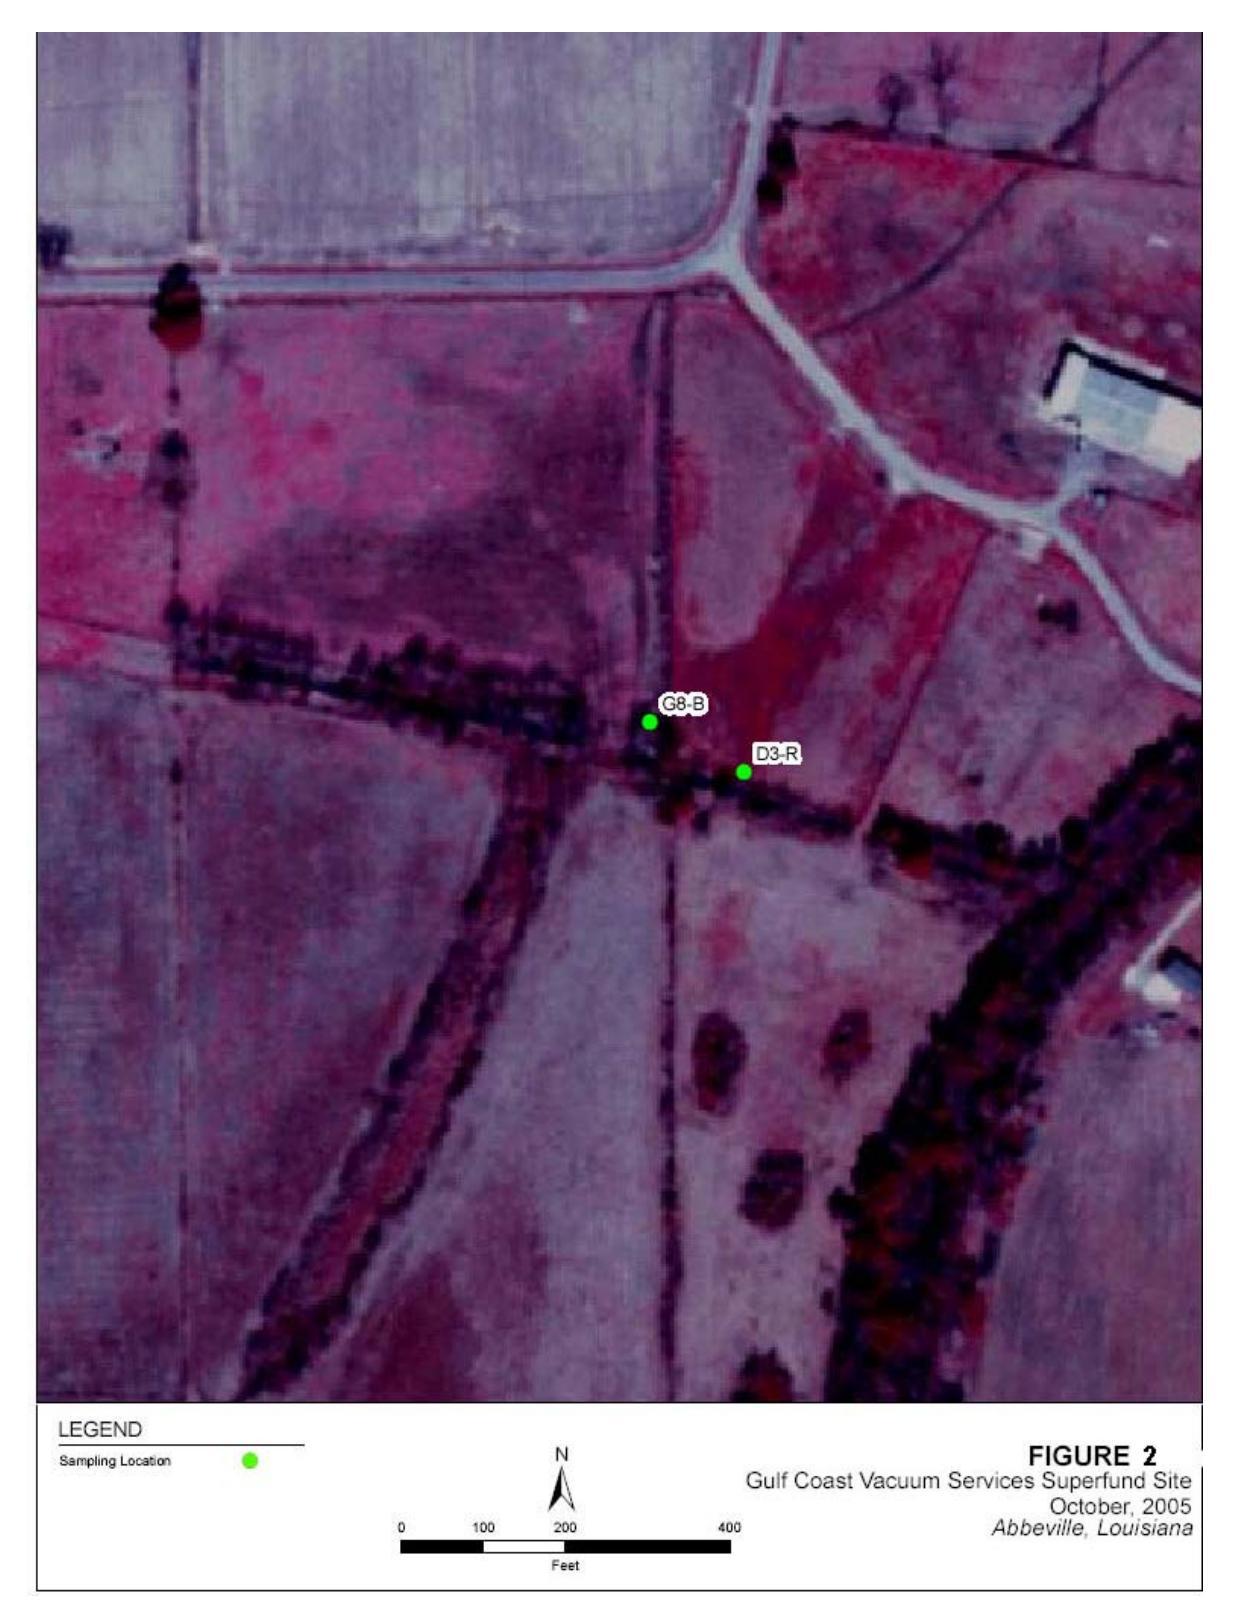
Groundwater samples were collected from each of two on-site monitoring wells. The location of these two monitoring wells is shown in Figure 2. Contaminant levels detected within these wells were found to be comparable to those recorded in the 2003 Five-Year Review, from which it was concluded that the concentrations of metals in the site groundwater were not affected by Hurricane Rita [4-6].

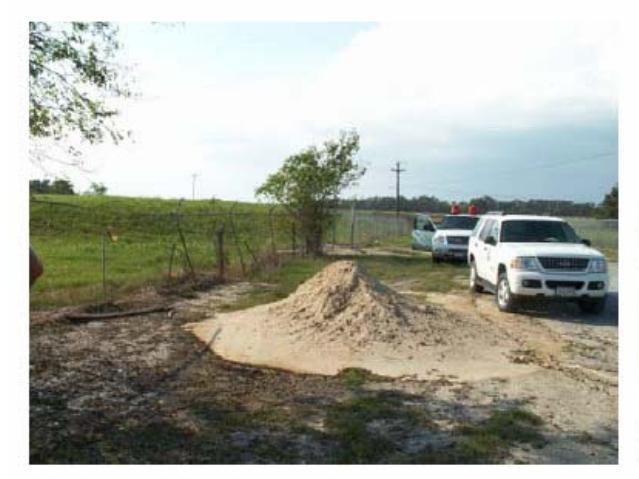
File Name: GSV_photo1.JPG Date/Time Taken: 01 Oct 2005 1625 Description: Fence line of site intact and not compromised by storm, view to west. N29°57'29.9"; W92°11'11.3"

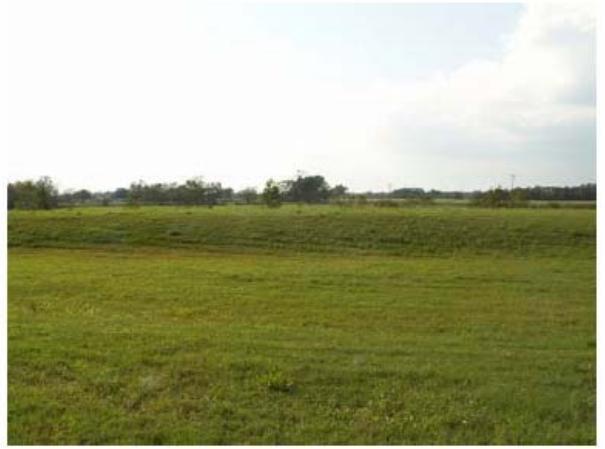
File Name: GSV_photo2.JPG Date/Time Taken: 01 Oct 2005 1631 Description: View to northwest of cap, showing no subsidence, ruts, or cracks due to storm. N29°57′28.1″; W92°11′11.4″

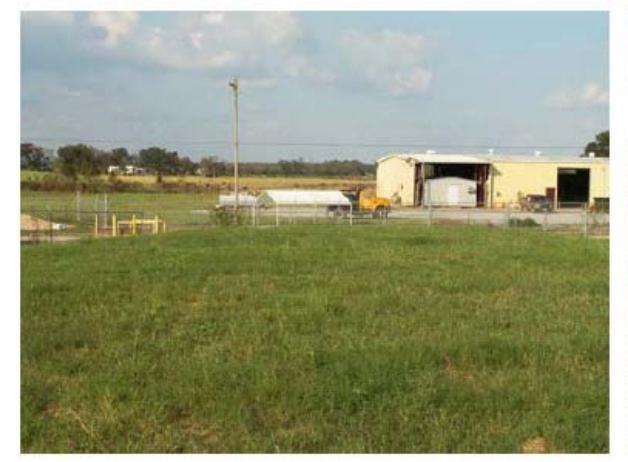
File Name: GSV_photo3.JPG Date/Time Taken: 01 Oct 2005 1636 Description: Eastern portion of cap, with equipment storage/maintenance facility in background, view to north. N29°57′28.1″; W92°11′11.4″

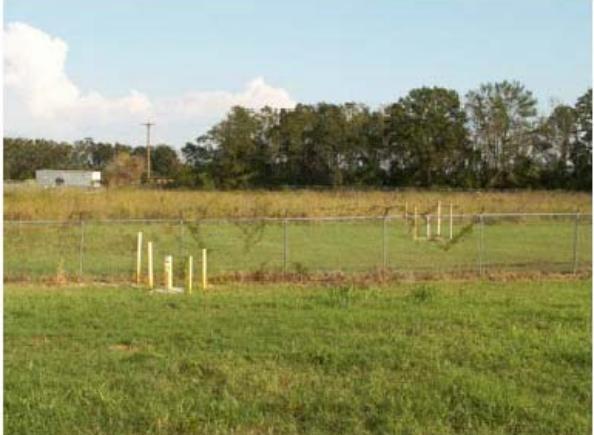
File Name: GSV_photo4.JPG Date/Time Taken: 01 Oct 2005 1641 Description: Boundary fence between Gulf Coast Vacuum and D.L. Mud sites, view to east. N29°57′28.1″; W92°11′11.4″

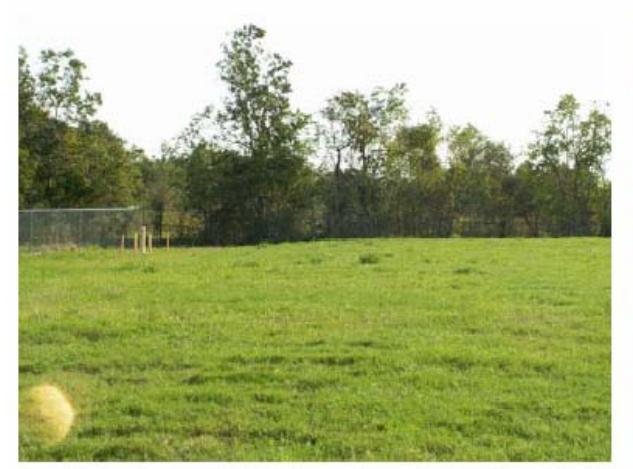
File Name: GSV_photo5.JPG Date/Time Taken: 01 Oct 2005 1642 Description: Monitoring well D-7R and site boundary, view to southwest. N29°57′28.1″; W92°11′11.4″

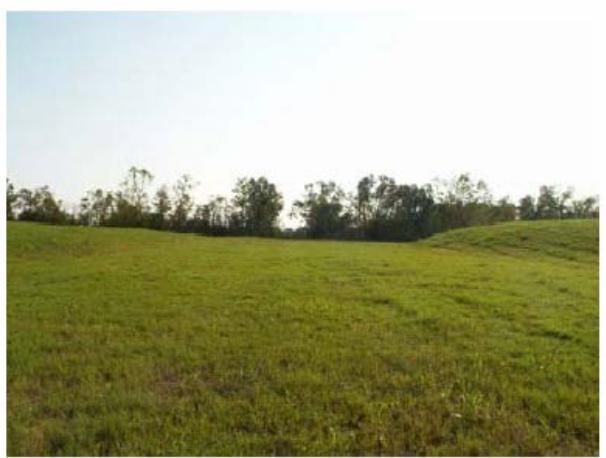
File Name: GSV_photo6.JPG Date/Time Taken: 01 Oct 2005 1649 Description: Low area between eastern and western caps, view to south. N29°57'29.3"; W92°11'11.6"

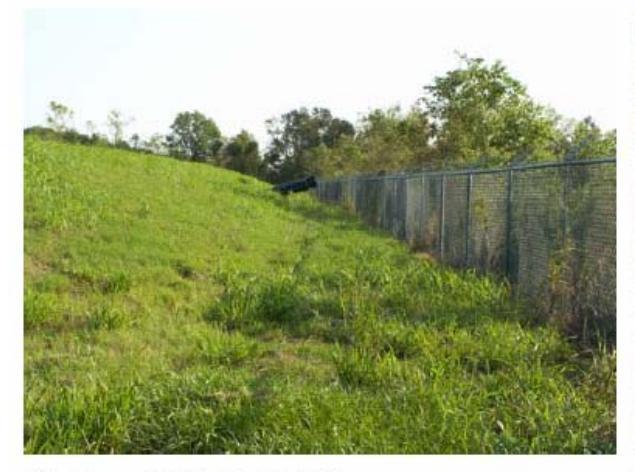
File Name: GSV_photo7.JPG Date/Time Taken: 01 Oct 2005 1652 Description: View to south along western fence and site boundary, showing intact sumps on side of cap. N29°57'31.9"; W92°11'14.1"

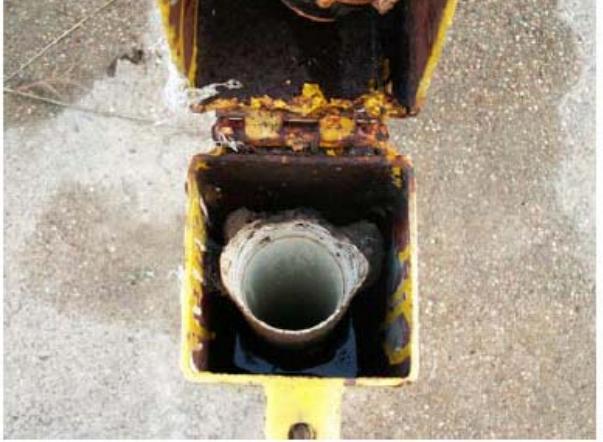
File Name: GSV_photo8.JPG Date/Time Taken: 01 Oct 2005 1733 Description: Warped top of riser pipe, well D-3R. N29°57'26.2"; W92°11'13.1"

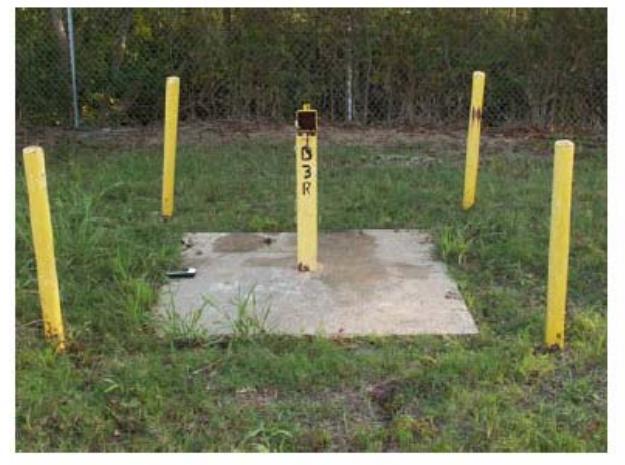
File Name: GSV_photo9.JPG Date/Time Taken: 01 Oct 2005 1634 Description: View to south of well D-3R (location for sample GCV001). N29°57′26.2″; W92°11′13.1″

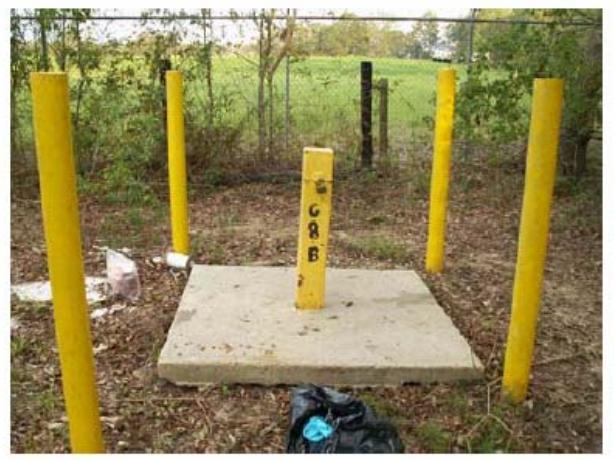
File Name: GSV_photo10_WellPad_G-8D-3.JPG Date/Time Taken: 01 Oct 2005 1730 Description: Well G-8B (location for sample GCV002). N29°57'26.8"; W92°11'14.4"

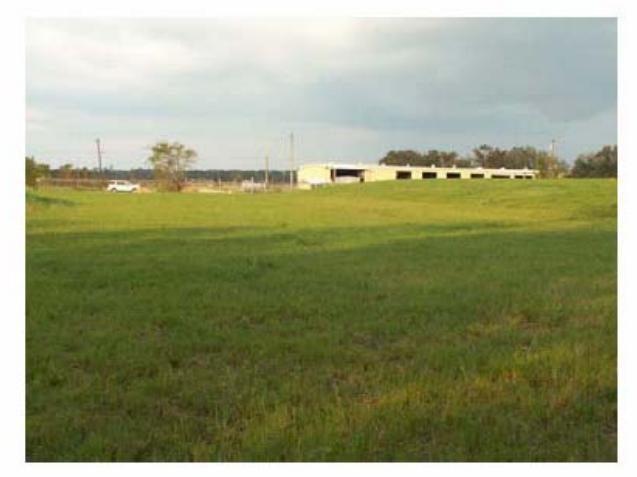
File Name: GSV_photo10_NorthView.JPG Date/Time Taken: 01 Oct 2005 1757 Description: View to north of western and eastern caps, showing no apparent storm impact. N29°57′26.6″; W92°11′14.0″
