Health Consultation

HURRICANE RESPONSE SAMPLING ASSESSMENT FOR
GULF STATES UTILITIES COMPANY
(A/K/A NORTH RYAN STREET FACILITY)

LAKE CHARLES, CALCASIEU PARISH, LOUISIANA

December 11, 2017

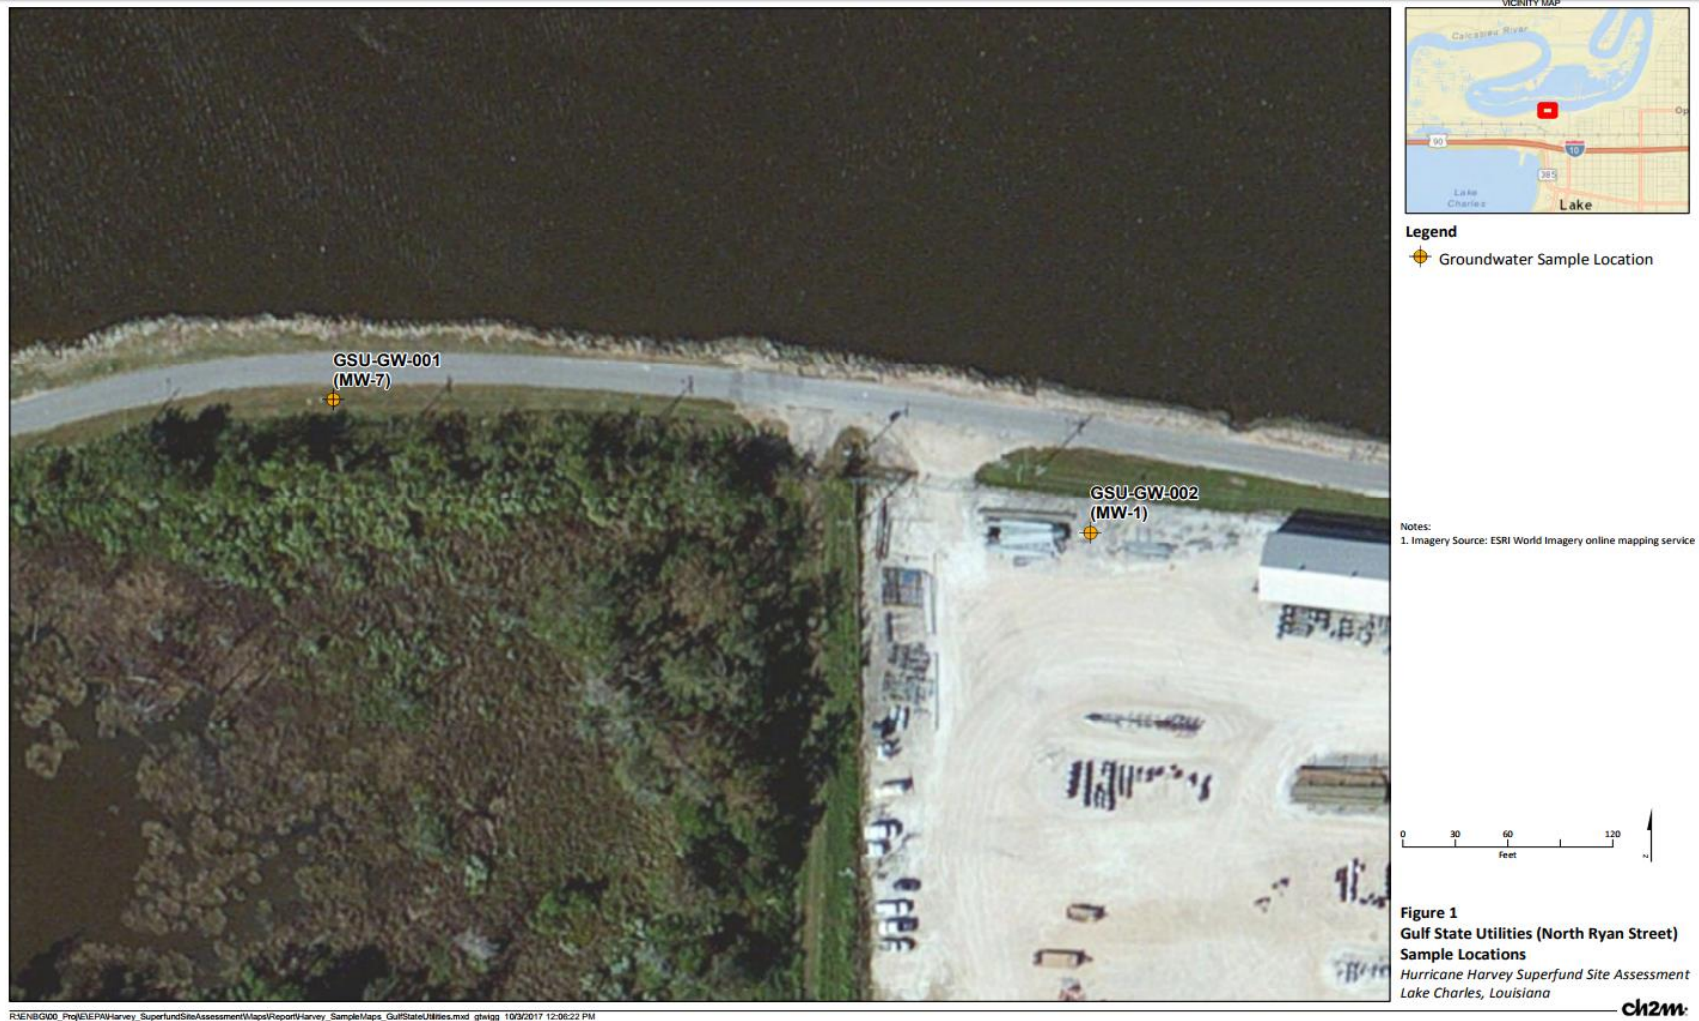
APPENDIX B: Gulf State Utilities-North Ryan Street Site Sample Locations

Groundwater samples were collected from two monitoring wells (MW-1 and MW-7) at the site on September 13, 2017, and analyzed for target volatile organic compounds (VOCs) and target semi-volatile organic compounds (SVOCs) to evaluate the potential effects from Hurricane Harvey. Appendix B shows the location of the two wells sampled at the site. Groundwater samples for VOC and SVOC analysis were submitted to EPA's Portable High-Throughput Integrated Laboratory System (PHILIS) mobile laboratory. The VOCs were analyzed using gas chromatography-mass spectrometry (GC/MS) by EPA Method 8260C, and the SVOCs were analyzed using GC/MS by EPA Method 8270D. Laboratory results were submitted directly to the EPA. At the direction of the EPA, no soil samples were collected at this site for analysis [7]. The site inspection team noted no visible issues on the property. Appendix C includes photographs taken during the site visit.

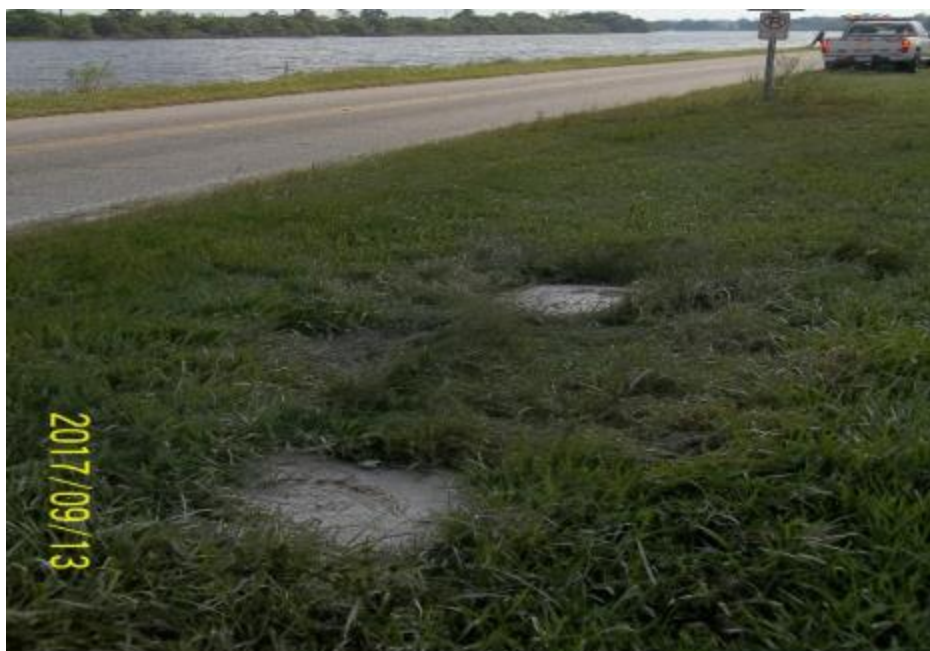
Date/Time: 09/13/2017 10:04 a.m.

Looking northeast across two flush mount monitoring wells. The sampled well MW-7 is the furthest well (near the center of the picture).

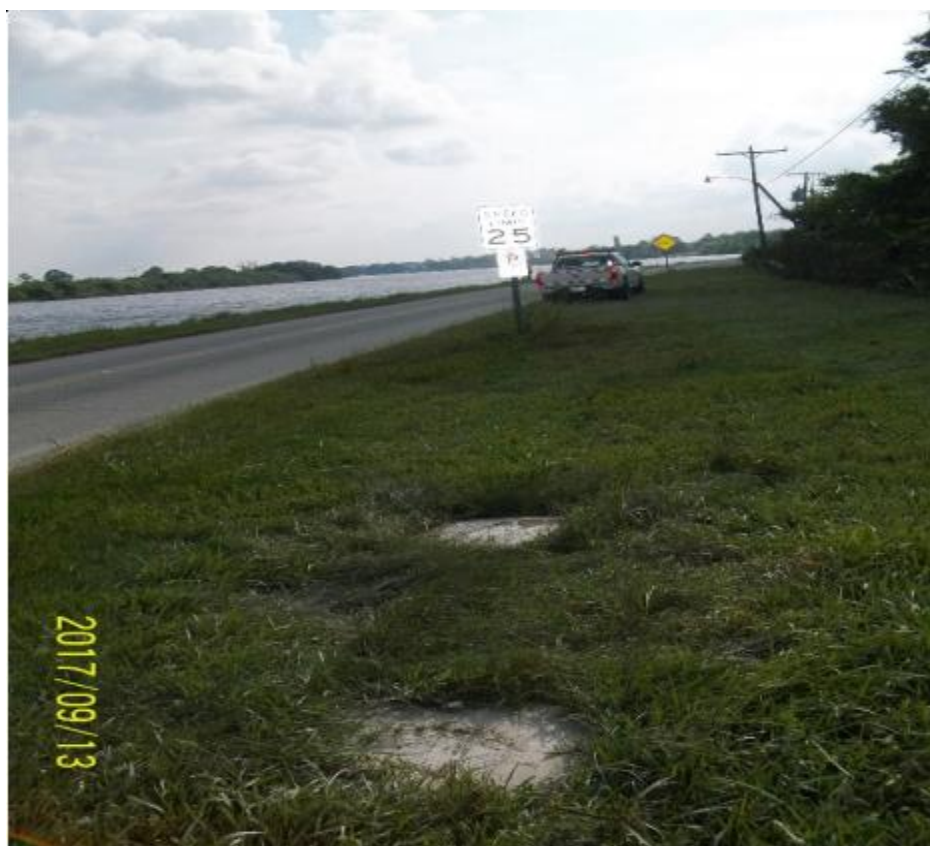
Date/Time: 09/13/2017 10:04 a.m.

Looking northeast with MW-7 in the foreground (from about 8 feet away).

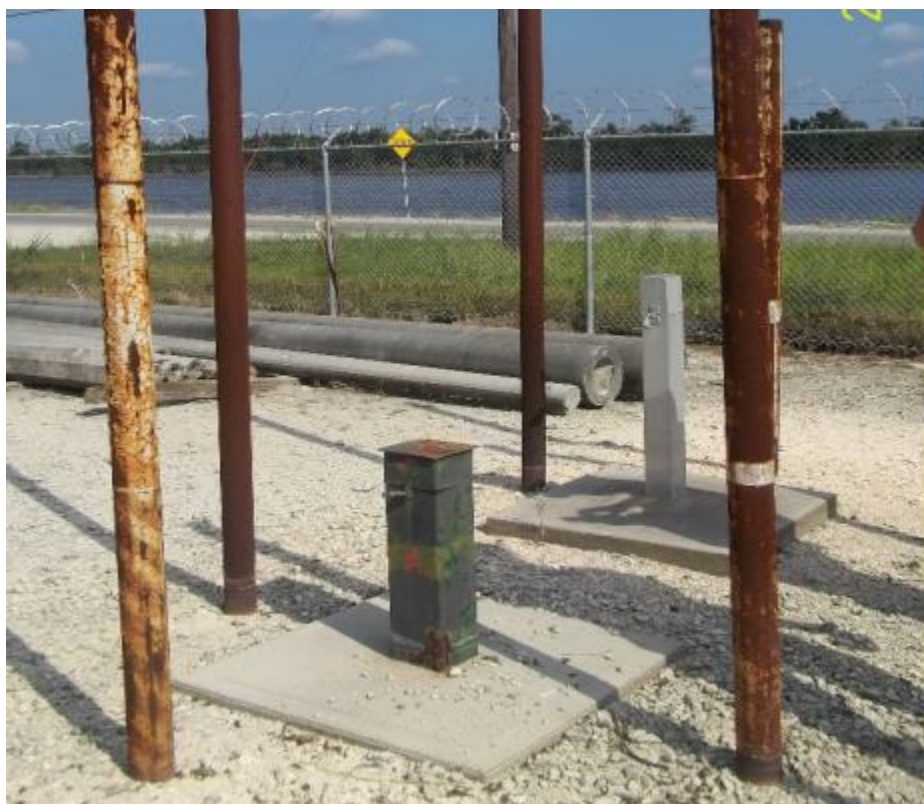
Looking northwest across two site monitor wells toward the river. Sampled well MW-1 is the furthest well in this picture (closer to the river).
Date/Time: 09/13/2017 10:15 a.m.

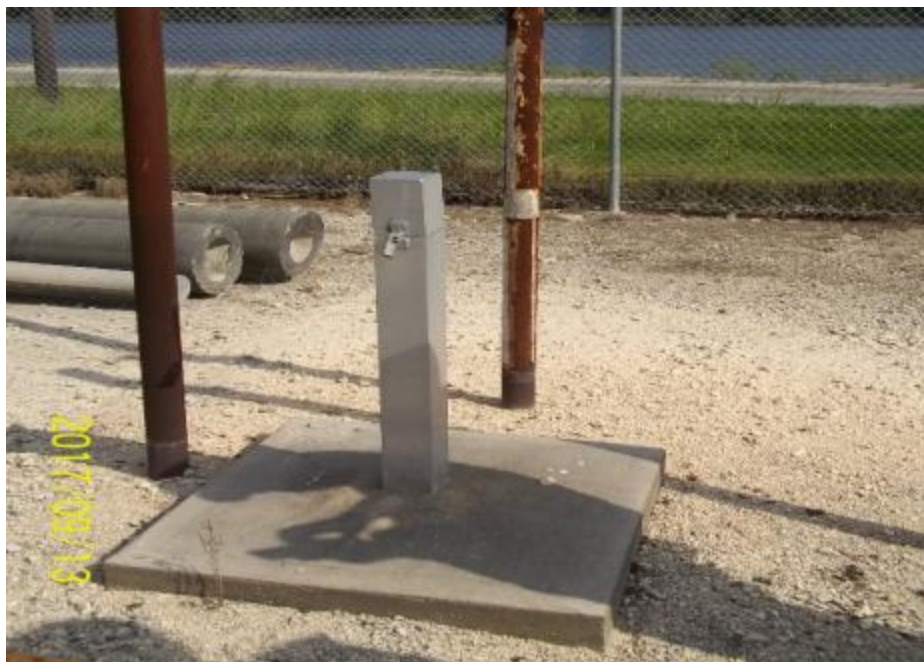
Looking north at MW-1; river in background.
Date/Time: 09/13/2017 10:15 a.m.

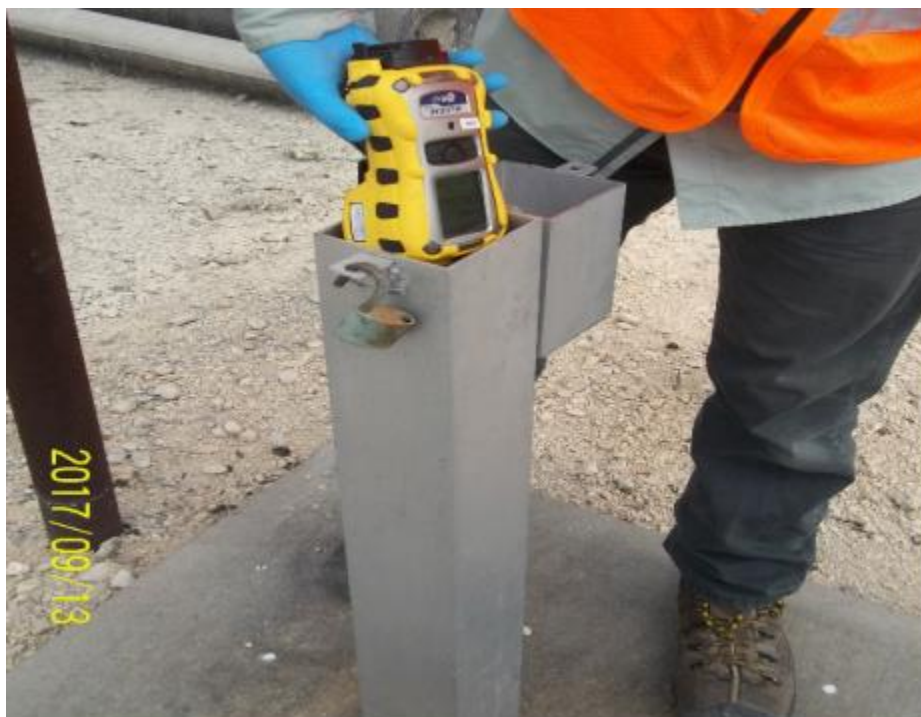
Air monitoring at MW-1 at the start of sampling.
Date/Time: 09/13/2017 10:27 a.m.

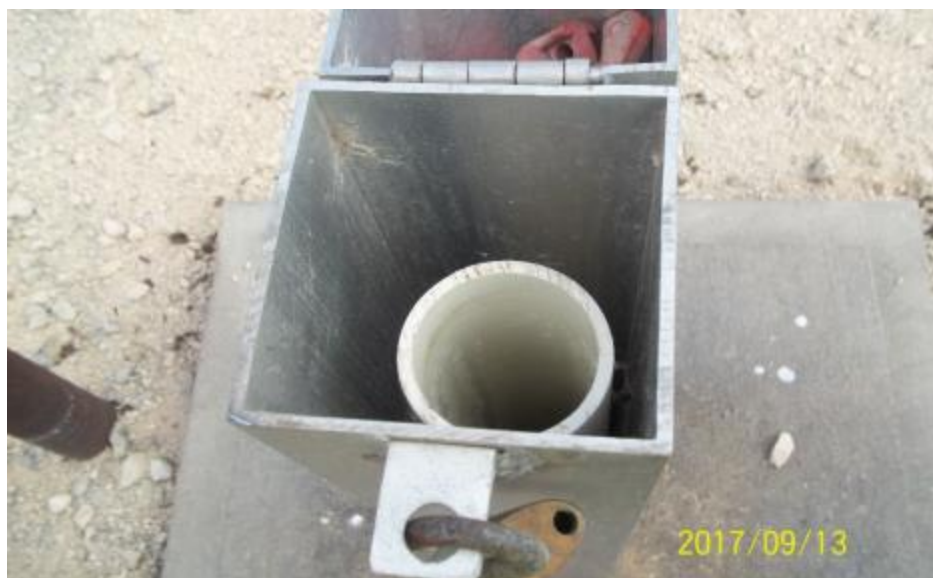
Date/Time: 09/13/2017 10:27 a.m.

Looking down well casing at MW-1.
